Manhole Inspection Summary

Manhole # S41Y1_035MH

Record Plat: **41Y1** Node: **035** Status: **New Manhole (Not in GIS)** Insp Date: **4/8/09 12:00 AM**

Location Address: **3611 Brooklyn Ave**

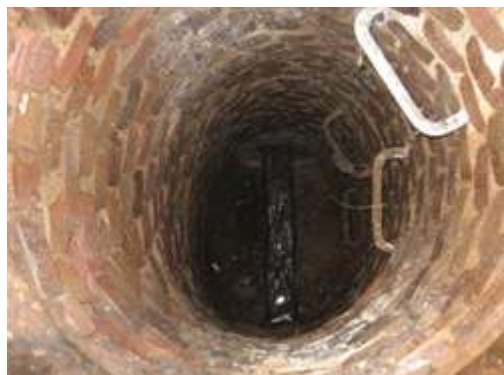
Top View

Inspection ☐ Is Incomplete Rating: **2) Good**

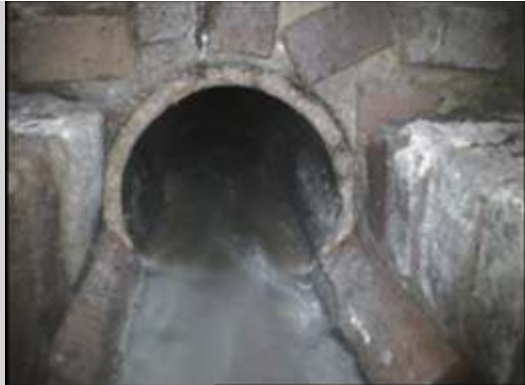
12 O'Clock Outflow

8 in. Circular Gravity Sewer
Pipe Out @ 12 O'Clock

Pipe Height: **9.6** (in.) Rod and Bar (Angled)
Pipe Material: **Clay** ☐ Pipe Lined
Invert Depth: **11.30** (ft.) Flow Characteristics: **Fast**
Deposits: ☒ None ☐ Mud ☐ Sludge ☐ Debris ☐ Grease
Silt Depth: (in.) Deposits Extent:
Infiltration: **None** Pipe Seal Cond: **Sound**

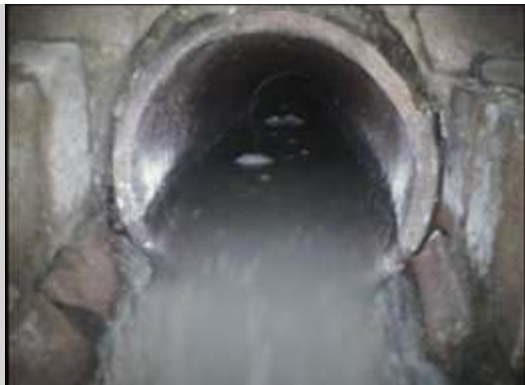
6 O'Clock Inflow

8 in. Circular Gravity Sewer
Pipe In @ 6 O'Clock

Pipe Height: **10.8** (in.) Rod and Bar (Angled)
Pipe Material: **Clay** ☐ Pipe Lined
Invert Depth: **11.14** (ft.) Flow Characteristics: **Fast**
Deposits: ☒ None ☐ Mud ☐ Sludge ☐ Debris ☐ Grease
Silt Depth: (in.) Deposits Extent:
Infiltration: **None** Pipe Seal Cond: **Sound**
